Corrosion and Conservation Management of the Submarine HMAS *AE2* (1915) in the Sea of Marmara, Turkey

Ian D MacLeod*

Western Australian Maritime Museum, Australia

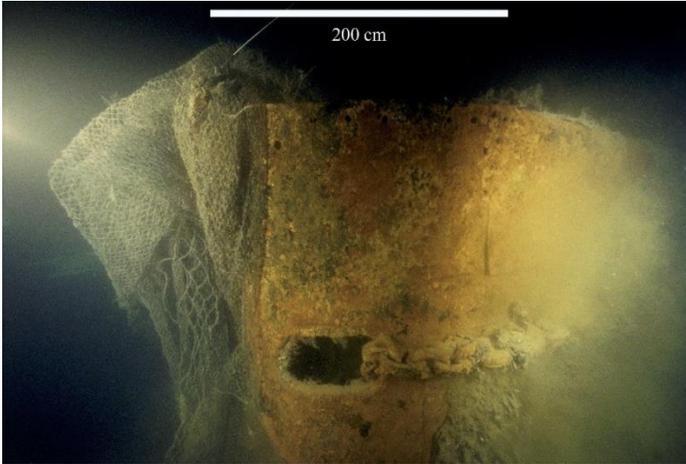
Figure 3: Trawler net damage on the AE2 submarine.

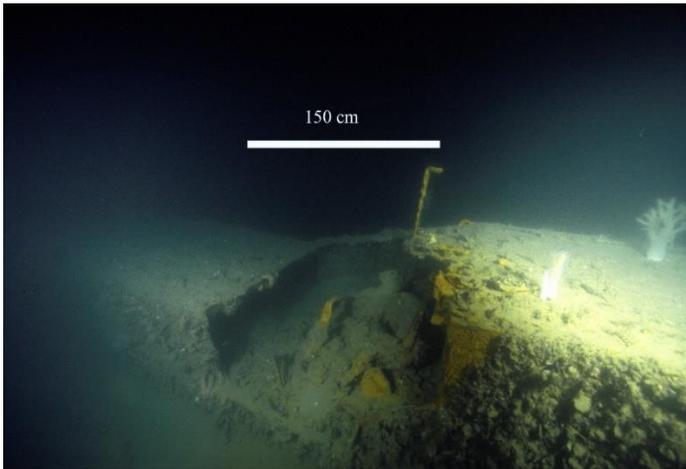
Figure 4: Corrosion damage to the casing of the AE2; yellow shows active corrosion.

Proximity corrosion refers to long-distance galvanic coupling found on historic shipwreck sites and on submerged off-shore modern structures, such as production gas and oil platforms. When dissimilar metals are covered with a concretion layer, they lose their electrical isolation, and the more reactive metals corrode while the more noble alloys are protected.

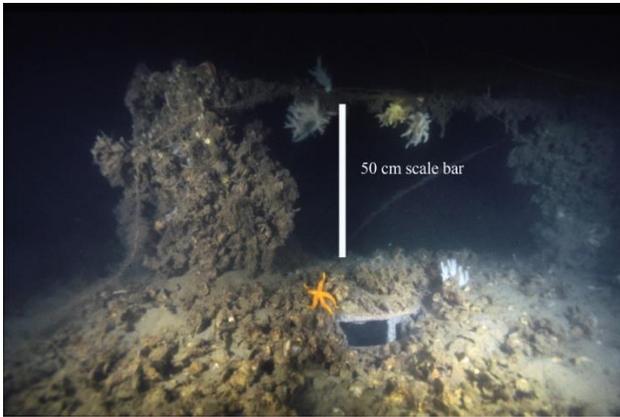
A barnacle from the base of the concretion was a deep charcoal grey to black, which is likely to be associated with magnetite, the corrosion product associated with iron corrosion in a low oxygen environment.

Figure 5: Concreted main hatch way showing the 10 cm gap for insertion of the drop camera and the very thick marine concretion deposits.

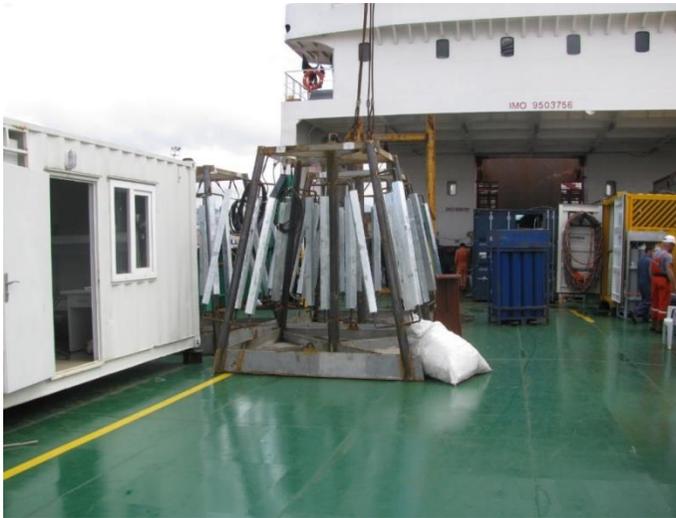
Figure 9: View of assembled anode pods prior to attachment to AE2.

The anode pods were assembled on a 2.6 m sided square base, which was filled with concrete to prevent them sinking into the silt. The supporting structure weighed 0.5 tonnes, giving an aggregate weight of around 1.5 tonnes to each pod. Each anode (150 × 7.5 × 7.5 cm) had a central iron core, to which insulated current-carrying cables were attached (Figure 10). The distal end of the cable was attached to the submarine using an industrial

three bolt system, as used in the cathodic protection of gas and oil production facilities. The 17 anodes on each pod had a geometric surface area of 7.84 m^2 . In order to achieve a good spread of protection through the length of the boat, one pod was attached aft near the rear hydroplane, one amidships at the conning tower and one up forward on the windlass (Figure 10). With an estimated geometric surface area of approximately 660 m^2 for the submarine and with the area of the anodes at 23.5 m^2 , the industry standard ratio of approximately 30 times object to anode ratio was achieved. This ratio helps to avoid damage to the submarine if it was over-protected, as this could produce too much hydrogen pressure, which would blast off the protective concretion and lead to excessive consumption of anodes.

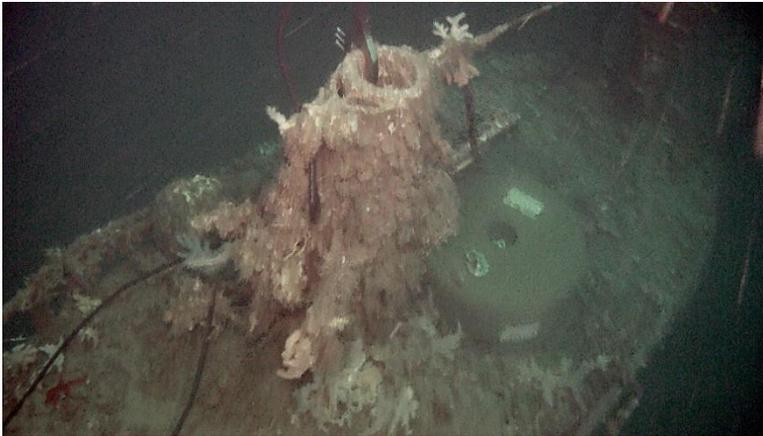
Figure 10: Clamp and cable arrangements for central anode pod connection to the conning tower. Note the replica hatch is in the “locked down” position.

Prior to attaching the anode cables with clamps to the submarine, the surfaces were hydro-blasted to remove small areas of concretion from the metal surface to get ohmic connections. The elapsed time at each attachment point was measured from the time at which the pods were attached and the time when the E_{corr} measurements were taken. The observed voltages were dependent on the logarithm of the elapsed time between anode attachment and voltage measurement. The linear regression analysis gives Equation 6, which had an R^2 of 0.9648 with an associated equation,
