Corrosion and Conservation Management of the Submarine HMAS *AE2* (1915) in the Sea of Marmara, Turkey

Ian D MacLeod*

Western Australian Maritime Museum, Australia

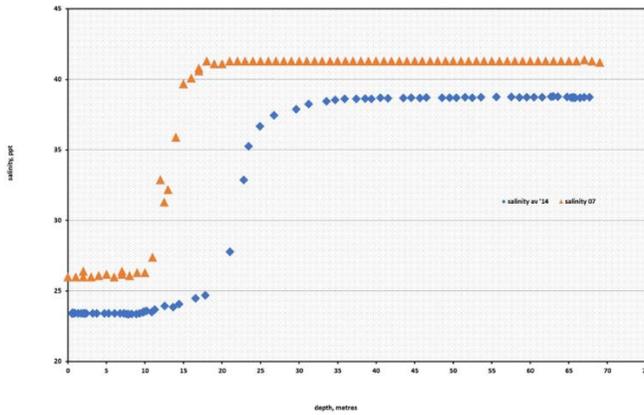
During the 2004 assessment, the water column above the wreck was measured for salinity, dissolved oxygen (YSI probe) and temperature at 0.5-metre intervals, using a TPS 90DC meter that logged the data, to a maximum depth of 73 metres. The first 13 metres had a mean salinity of $26.1\text{‰} \pm 0.1\text{‰}$, which reflects evaporative concentration of the 18‰ water inflowing from the Black Sea. Over the next eight metres, the salinity rapidly increased to $41.3\text{‰} \pm 0.8\text{‰}$ at the bottom of the halocline. The higher salinity is typical of the hypersaline Aegean Sea, which enters the Sea of Marmara via the Dardanelles. Captain Stoker had used this counter current to help him penetrate the mined straits. At the 2004 halocline there was a corresponding thermocline (change in temperature) where the temperature fell from 26 to 18 °C and a second thermocline, at 40 metres, saw the temperature fall from 18 to 16 °C, which was due to the heat capacity of the higher salinity water (Figure 1).

Figure 1: Salinity on the AE2 site in September 2007 (orange triangles) and June 2014 (blue diamonds).

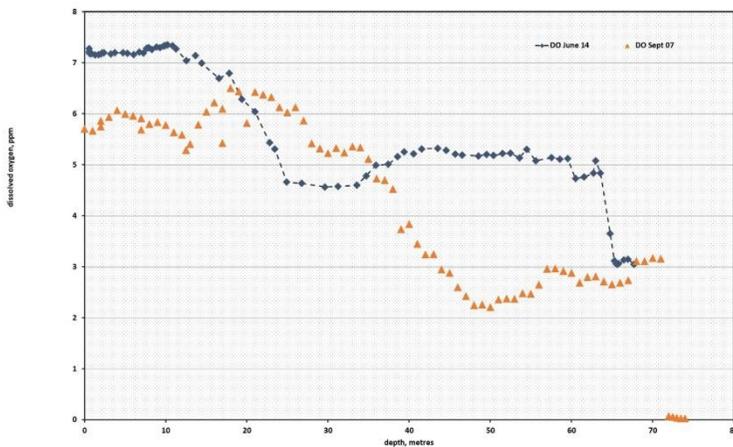
The surface waters in the Sea of Marmara were well oxygenated between 7 and 5.5 ppm, as shown in the 2007 and 2014 profiles shown in Figure 2. The data from 2007 shows the dissolved oxygen falling from 5 to 3 ppm as the depth increases from 35 to 50 metres. At the upper sections of the submarine, the dissolved oxygen was recorded at 2.8 ± 0.2 ppm, which represents 36% saturation of the seawater for a salinity of 41.3‰ at 16 °C [6].

Figure 2: Dissolved oxygen vs. depth for the AE2 site; the zero-ppm data in 2007 (orange triangles) is when the weighted probe penetrated the silt mound. June 2014 data blue diamond shapes.

The data from June 2014 showed a dissolved oxygen that fell with increasing salinity, to reach a minimum of 4.5 ppm, and then increased in response to currents flowing in the hypersaline waters at depths until the submarine environment was reached, at 67 metres, where it fell to the 3-ppm level seen in 2007.

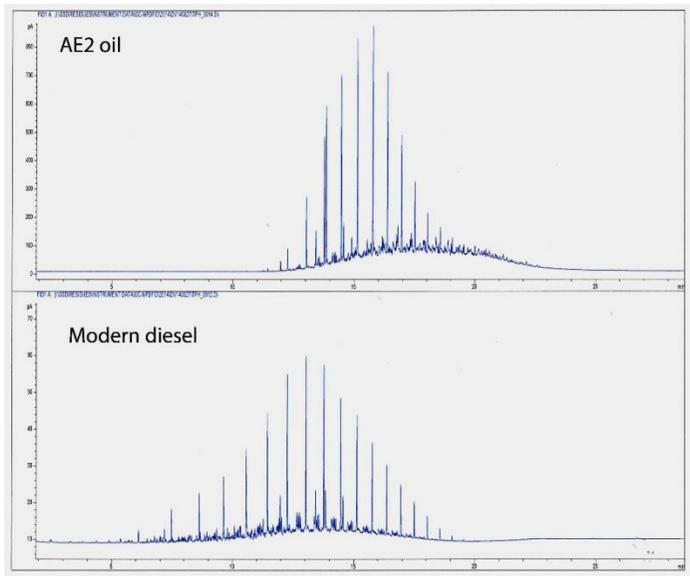
Samples of oil from inside the boat were collected from the surface of the ROV following its successful navigation of the internal spaces of the engine room. Viscosity data and gas chromatographic analysis of the volatile organic compounds coming from the oily residue indicated that it was diesel fuel, which had been leaking from the forward tanks. The analysis showed that the oil was biologically fractionated through removal of the sour and acidic smelling thiols and thiophenes. The bacteria preferentially consumed much of the long chain alkanes of the general formula $\text{C}_n\text{H}_{2n+2}$ (Figure 6). The biodegradation of the AE2 oil mixture was indicated by the presence of the branched alkanes, norpristane ($\text{C}_{18}\text{H}_{38}$), pristane ($\text{C}_{19}\text{H}_{40}$) and phytane ($\text{C}_{20}\text{H}_{42}$), which are much more stable than the branched hydrocarbons. It is interesting that pristane is derived from shark liver oil and so this may be one of the

principal components of lubricating oils and diesel fuel for the generators that was recovered from the surface of the ROV. The video inside the submarine has evidenced movement of large black mats of biological growth, which are the by-products of the microbiological attack on the diesel fuel.

Figure 6: Gas chromatographs of AE2 oils compared with undegraded diesel fuel.

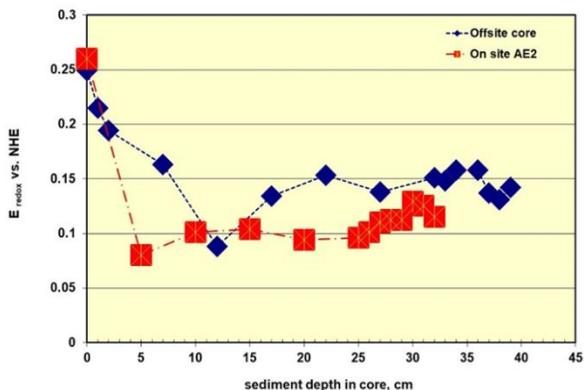
A fundamental archaeological principal is to establish what impact a given deposit has on its immediate microenvironment and vice versa. Thus, core samples were recovered in the immediate vicinity of and at 20 metres distance from *AE2*. The cores were chemically characterized through measurements of the dissolved oxygen, pH and redox potentials. The mean redox potential of the sediment core adjacent to the vessel was $+0.119 \pm 0.044$ volts vs. NHE (Normal Hydrogen Electrode), which was statistically indistinguishable from the off-site core, $+0.157 \pm 0.038$ volts (Figure 7).

Figure 7: Voltage E_h readings on the two cores relative to the Normal Hydrogen Electrode.

The $^{AE2} E_h$ fell by 180 mV, from 0.260, in the first five cm of sediment, while the off-site sample took 30 cm to fall to the same minimum value of 0.082 ± 0.003 volts. The more rapid fall in the redox potential for the AE2 core indicates that the microenvironment near the submarine rapidly becomes anaerobic as a direct result of the corrosion process consuming oxygen trapped in the silt. This is supported by the observation that as the core depth increased the AE2 core remained relatively constant at 0.107 ± 0.014 volts, while the off-site redox potential had a mean value of 0.142 ± 0.020 or some 35 mV more oxidizing than that by the submarine (Figure 7). This indicates that the distance of the impact of the submarine on the microenvironment is less than 20 metres.

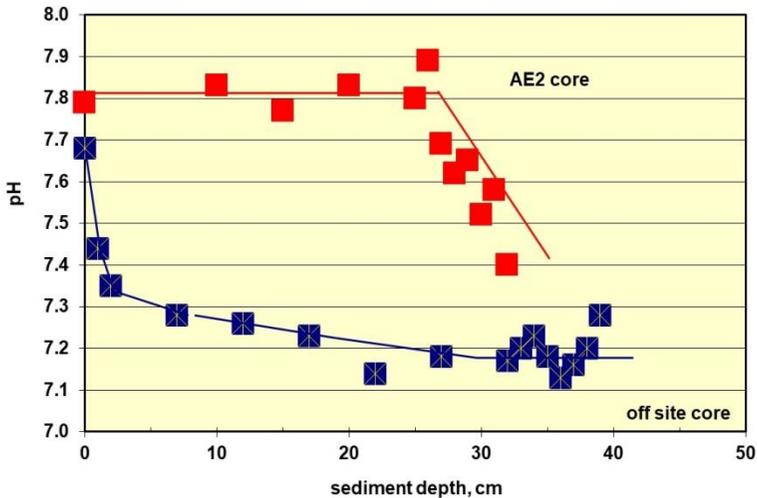
Figure 8: pH of AE2 core profiles and off-site values.

The $^{AE2}pH_{core}$ values showed a steady alkaline microenvironment for the initial 25 cm at $pH\ 7.80 \pm 0.02$, before rapidly falling over the last 7 cm at a rate of $-0.05\ pH/cm$ distance down the core (Figure 8). The change in $^{AE2}pH_{core}$ may reflect a limiting impact of the vessel on the sediment, since the pH values for both cores coincided at 7.3 ± 0.1 after a core depth of ≈ 30 cm of sediment. The $^{off-site}pH_{core}$ rapidly fell from its initial value of 7.7 to 7.1 ± 0.1 in the first 25 cm of sediment. The dissolved oxygen measurements in the AE2 core recorded seven zero values, with a mean of 0.018 ± 0.023 ppm (i.e., essentially zero), while the off-site core mean was 0.067 ± 0.068 ppm with five zero values.

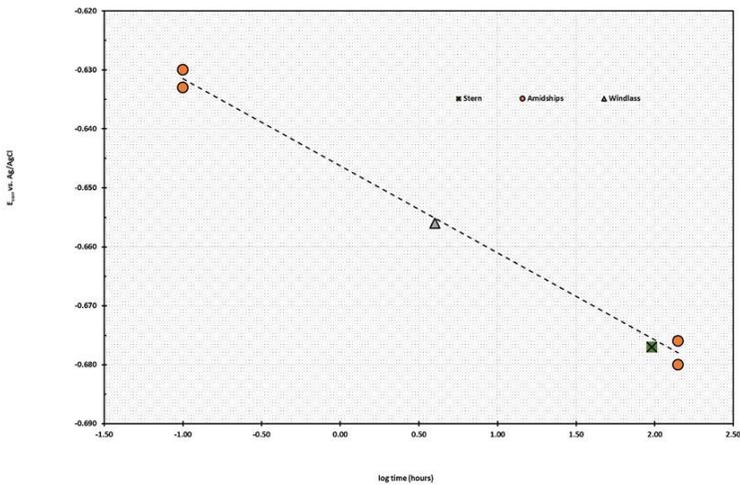
Figure 11: Plot of the E_{corr} values vs. log time (hours) after application of anodes.

The data in Table 1 shows that the greatest voltage drop between the natural cathodic protected E_{corr} of the conning tower was 50 mV after 141 hours or close to six days. This voltage drop is the equivalent of a 42% drop in the corrosion rate of the submarine, which is remarkable given the size of the boat! The E_{corr} values

are diagrammatically illustrated in Figure 11. This calculation is based on a combination of theoretical and practical determination of the rate at which the corrosion changes for concreted materials. For electrochemically controlled reactions, such as the in-situ treatment of the *AE2* submarine, the log of the corrosion rate can be calculated according to the changes in E_{corr} values, with a drop of approximately 330 mV needed for a ten-fold decrease in the rate of corrosion.

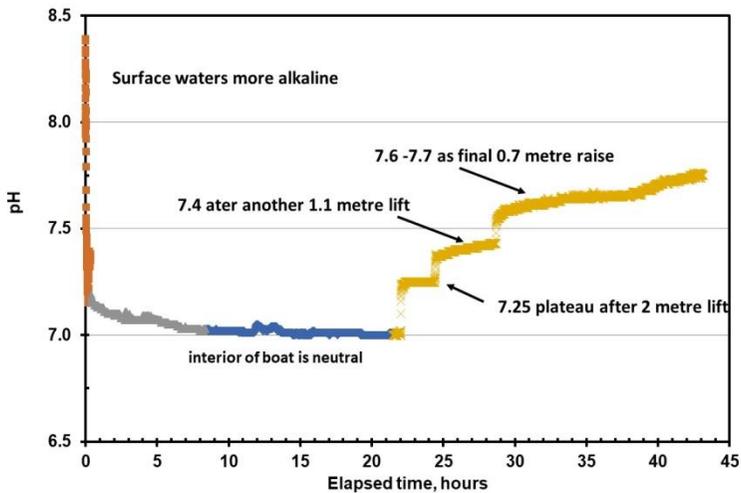
The pH data recorded by the Sonde is shown versus time inside the conning tower (Figure 12). The red-brown line shows a fall from the surface value that is within the normal range of pH for the Sea of Marmara, which has an average pH of 8.26 ± 0.18 . The green line represents the period when the Sonde was inside the submarine and operating as normal, which shows an average pH of 7.15 ± 0.03 , which is typical of marine sediments that have bacteria active in them.

Figure 12: Plot of the pH of the water column and interior of the submarine.

The extended blue line represents the period when the oxygen and salinity sensors were “poisoned” by sulphur species in the stirred-up sediment. When the divers began to recover the Sonde, the purple line and the plateau value of 7.2 represents the solution value in the water column above the sediment. As the instrument recovery operations increased, the plateau readings of 7.4 and 7.6 represent the different chemical microenvironments inside the submarine. The value of 7.4 is for the water 3.1 metres up from the floor of the control room and 7.6 is for water at 3.8 metres. The latter pH corresponds to the mean pH of the sediment cores from outside the submarine. The values between 7.2 and 7.4, those closer to the internal spaces of the lower control room, correspond with the mean pH (7.26 ± 0.08) from the external core adjacent to the submarine. The equivalent value at the first plateau region of the pH with the sediment core close to the submarine is a strong indication that the chemical processes of diagenesis inside the submarine were the same as those externally, but near the hull.

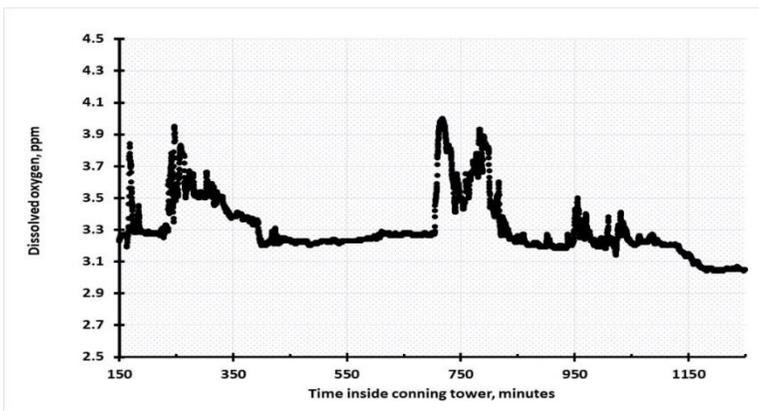
The dissolved oxygen inside the conning tower was generally around 3.2 ± 0.1 ppm but there were a series of rapidly rising and

falling spikes, which saw an upward excursion to approximately 4.0 ± 0.2 ppm. At times these elevated levels were restored to their former values with a sigmoidal decrease in the concentration of oxygen. This is probably due to bacteria that consumed oxygen. More generally, there was a rapid return to the steady state value, as shown in Figure 13. These phenomena indicate that there is mixing of different bodies of water inside the conning tower and that there is a significant level of microbiological activity inside the submarine.

Figure 13: Plot of dissolved oxygen vs. time inside the conning tower.

The specific time intervals have no meaning other than providing an insight into the fluid dynamics inside the submarine. There was an interval between 400 and 700 minutes when there was no apparent mixing of the layers of solution, but the time between oxygen spikes was typically $75 \pm$ five minutes. The varying speeds at which the elevated dissolved oxygen levels resumed their stasis values were due to which of the three processes were dominant: Firstly, there is natural diffusion from a high to a low concentration of oxygen, the second is bacterial consumption, and the third method is water movement around the sensing heads of the Sonde. Imaging recovered from the ROV showed large black algal mats. The simplest explanation of the oscillating oxygen levels is that the Sonde was positioned at a point where there was movement of different bodies of water inside the submarine, and that, at times, a more oxygenated
